Attachment A: Texas Instruments PowerPoint Presentations to EPA, June 24 and July 17, 2020

Texas Instruments NPDES Permit Renewal Letter to EPA Region 1

Texas Instruments, Attleboro, MA NPDES Permit

Attleboro Site -NPDES Outfall 002A Exceedances

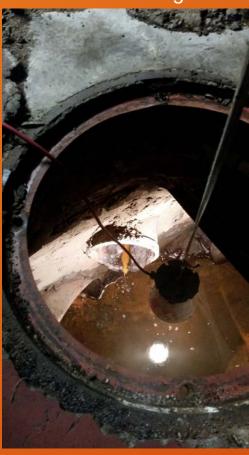
Pre-Sealing

Catch Basin Sealing (DMH-D in Building 3)

- Corrective Actions Implemented since 2014:
 - > Downstream drain cleaning to remove clog (2014);
 - > Stormwater influent line cleaning with acid wash (2014, 2015);
 - > Float switch and pump repairs/replacements (2016 2020);
 - ➤ Catch basin bottom sealings (2017);
 - ➤ Addition of pre-filtration of dry-weather flow (2018);
 - ➤ Replacement of CB-88 (2019);
 - Adjustment of overburden and storm sewer systems recovery flow rates (2017 2020);
 - Adjustments of level setpoints to ensure complete capture of dry-weather flow (2018 2020); and,
 - ➤ Cleaned effluent discharge pipe (2018 2020).

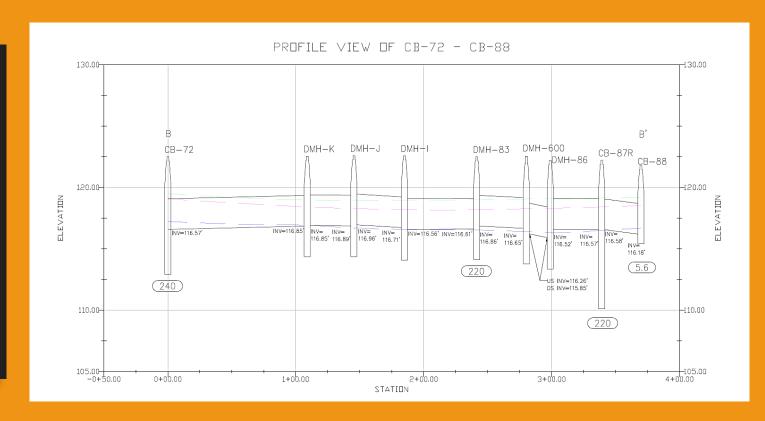
Example Storm Sewer Profile from 2019 Study

- Storm sewer line (DMH-F) cleanout June 2020.
- Catch basin sealing effectiveness testing June/July 2020.
- Flow measurement work on-going (continuation from 2019 studies):
 - Investigating groundwater infiltration to the subsurface storm water drainage system in the vicinity of the recovery and treatment system, to identify potential sources of significant infiltration, and to develop a strategy for improving the combined storm and groundwater recovery and treatment system efficiency.
- Overburden recovery system header pipe cleanouts June/July 2020.

(depicting elevations, water levels and TCE results)

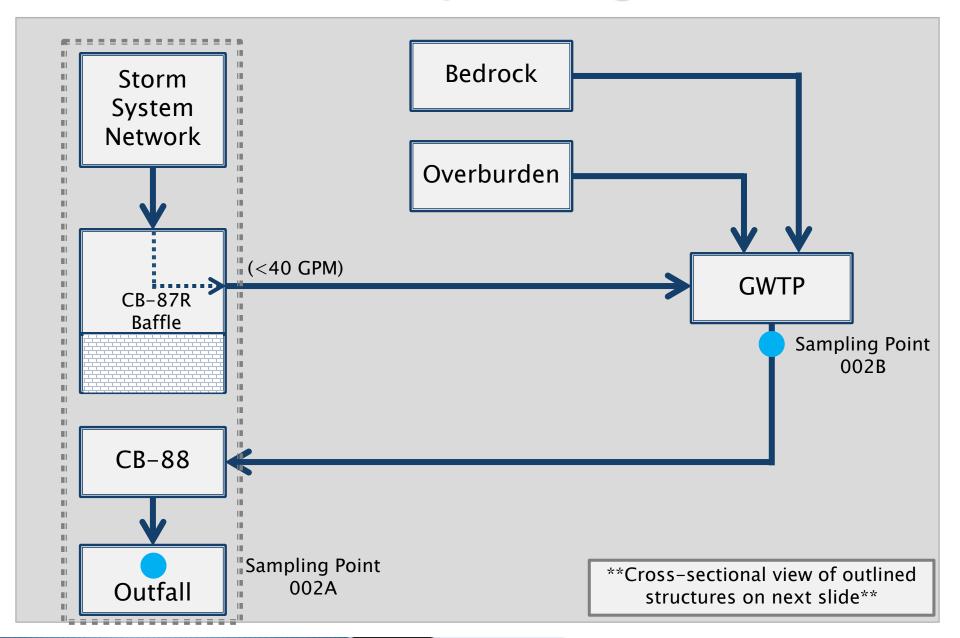
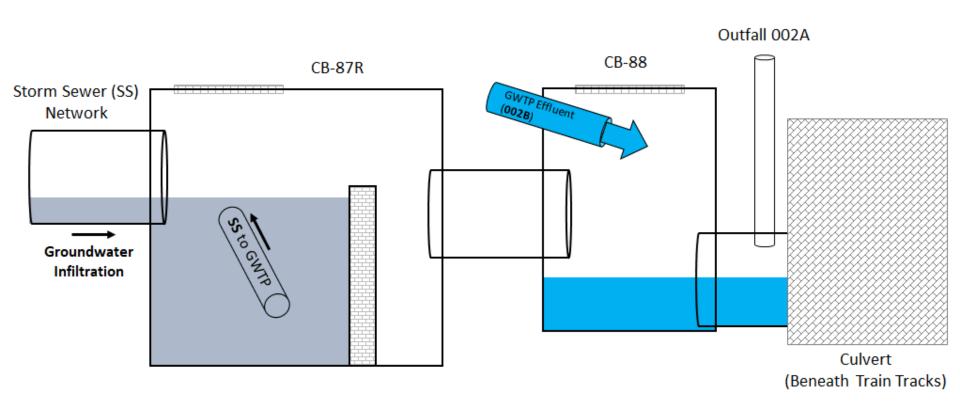
Under Normal Operating Conditions

- Treating Bedrock, Overburden, Groundwater Infiltration (GWI) at Groundwater Treatment Plant (GWTP)
 - 40 gpm is representative of full capture of contaminated groundwater infiltrating the storm sewer during dry weather conditions
- Treated water from GWTP exits 002B (below permit limits) and goes to 002A
- No exceedances at 002A

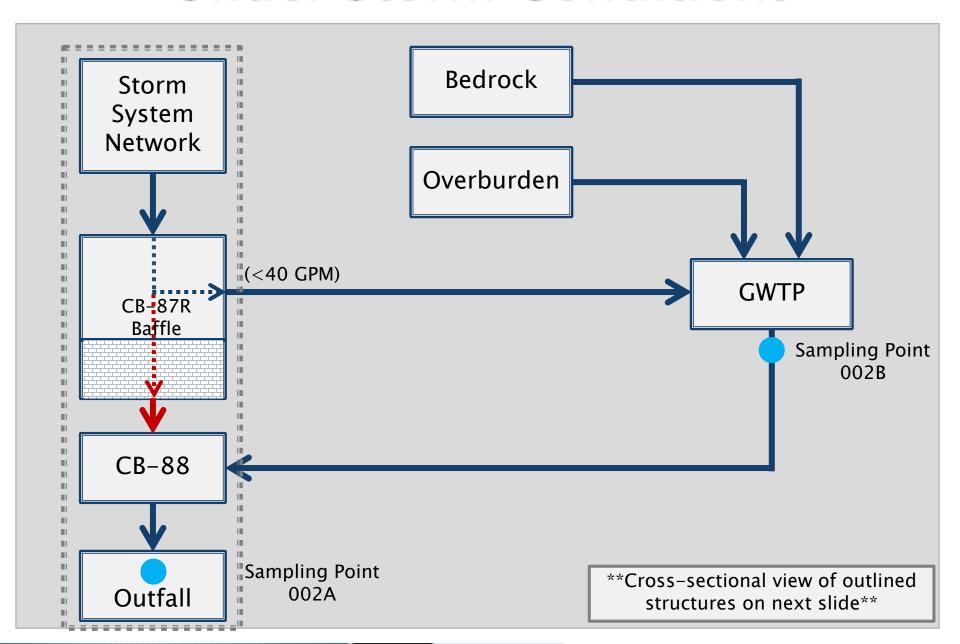
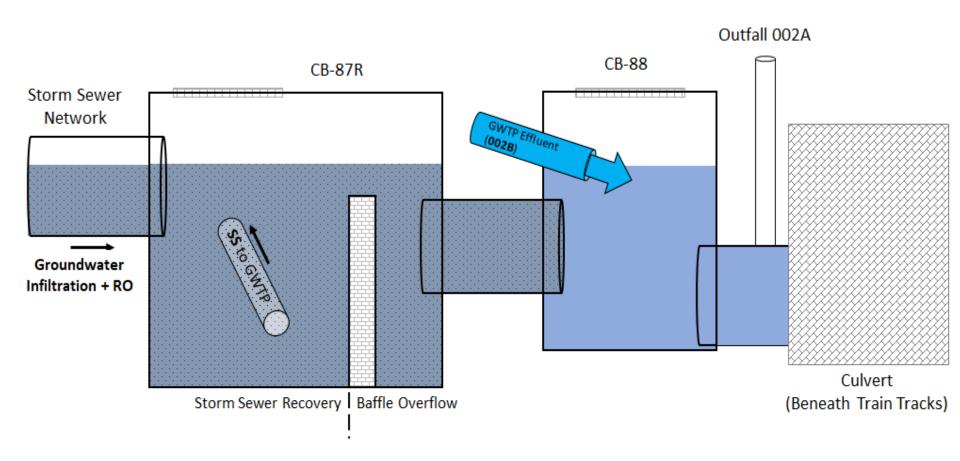
Under Storm Conditions

- Treating water from Bedrock, Overburden, Groundwater Infiltration (GWI), and Site Runoff
- Site runoff enters sewer and mixes with infiltrated contaminated groundwater
 - Flow above 40 gpm not captured
 - Mixed flow going over the baffle can contain TCE above permit limits and goes to 002A without being treated
 - Site runoff does not dilute GWI enough to be below permit limits which leads to exceedances

- System baffle causes runoff from storm events to accumulate or retained upstream
- The accumulated runoff can take longer than 48 hours to completely dissipate and the collection system return to normal operating (permit) conditions

TCE permit exceedances seen at 002A when storm events cause site runoff to enter storm sewer collection system and cause untreated water to go over the baffle wall

Include clause in new NPDES permit that extends the 48 hour wait time to apply when normal operating conditions cannot be achieved in a given month due to extended storm conditions (including subsequent runoff) greater than 0.1 inches that prevent representative sampling during dry weather conditions
